# Home Report

Clatto House 30E Bank Street  
Brechin DD9 6AX

# Single Survey

| <b>Prepared by</b> | Graham + Sibbald Property Consultants Limited |

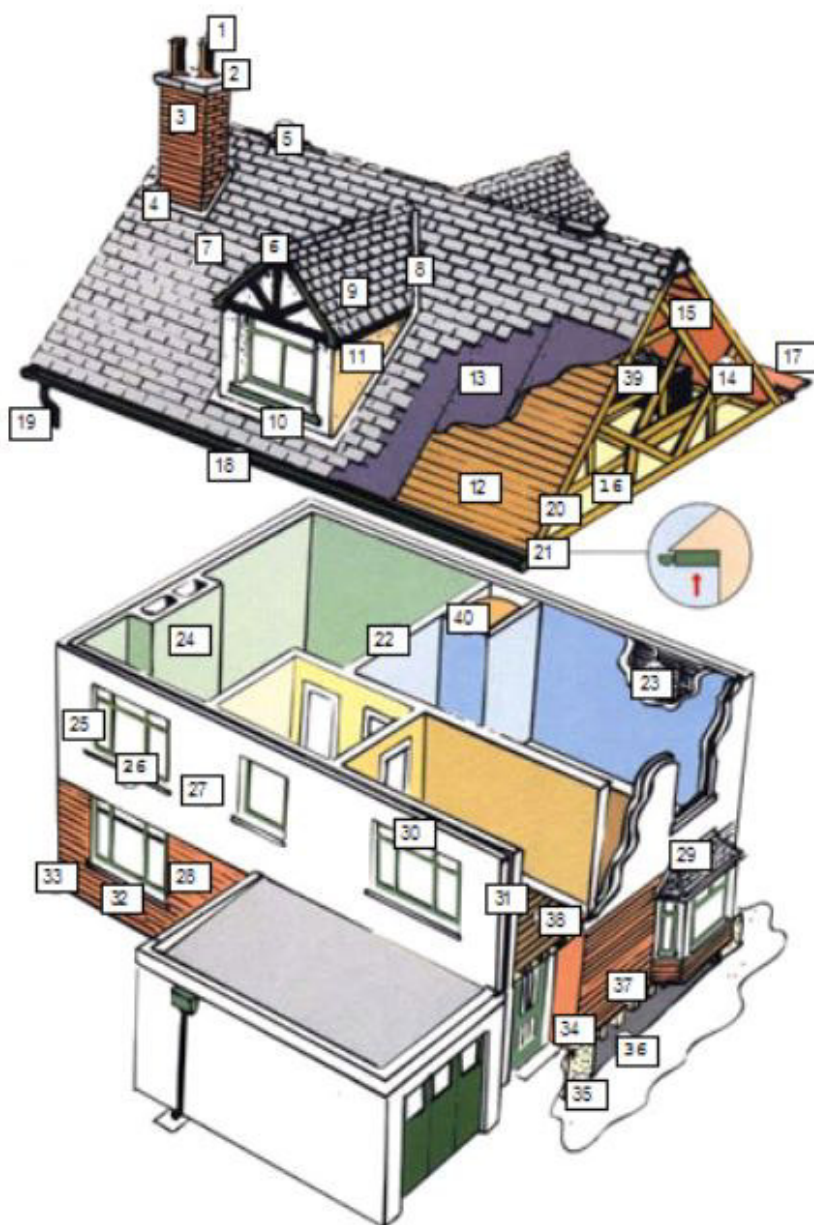
## Sectional diagram showing elements of a typical house

| 1 | Chimney pots |
| 2 | Coping stone |
| 35 | Foundations |
